Frontiers in Built Environment

Lessons Learnt From the 2009 Padang Indonesia, 2011 Tōhoku Japan and 2016 Muisne Ecuador Earthquakes

Keywords: earthquakes, Padang, Tōhoku, Muisne, buildings, foundations, landslides, geospatial tools

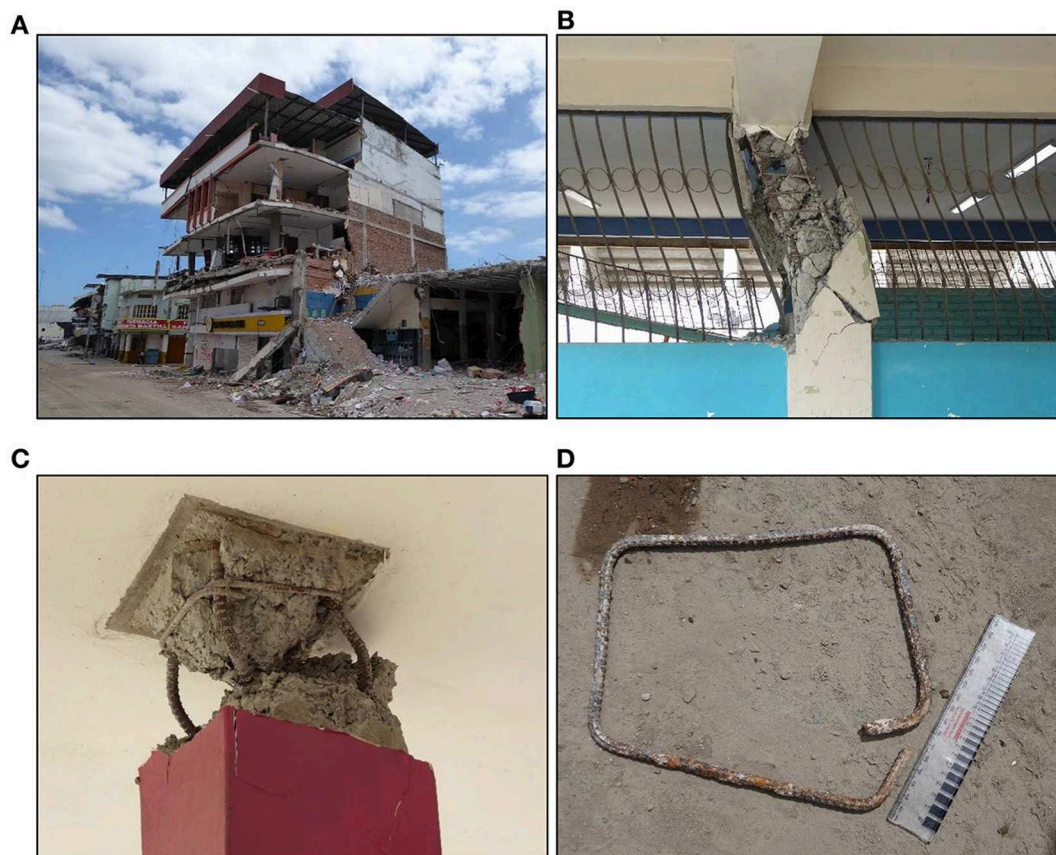
observed in several buildings (see **Figure 7A**). Column failure due to insufficient and poor shear design and detailing were also observed, some with poor lapping of link without 135° bend (see **Figures 7B–D**). There were also occasions where concrete cover was insufficient or missing (0–20 mm), which led to corrosion to the steel.

FIGURE 7 | Failures caused by inadequate design of infills and reinforcement detailing following the Muisne earthquake. **(A)** inadequate design/detailing of RC frame and infills at Portoviejo. **(B)** School building with short column failure at Pedernales. **(C)** Column head failure showing insufficient shear design at Portoviejo. **(D)** insufficient lapping of column link with no 135°-bend at Manta.

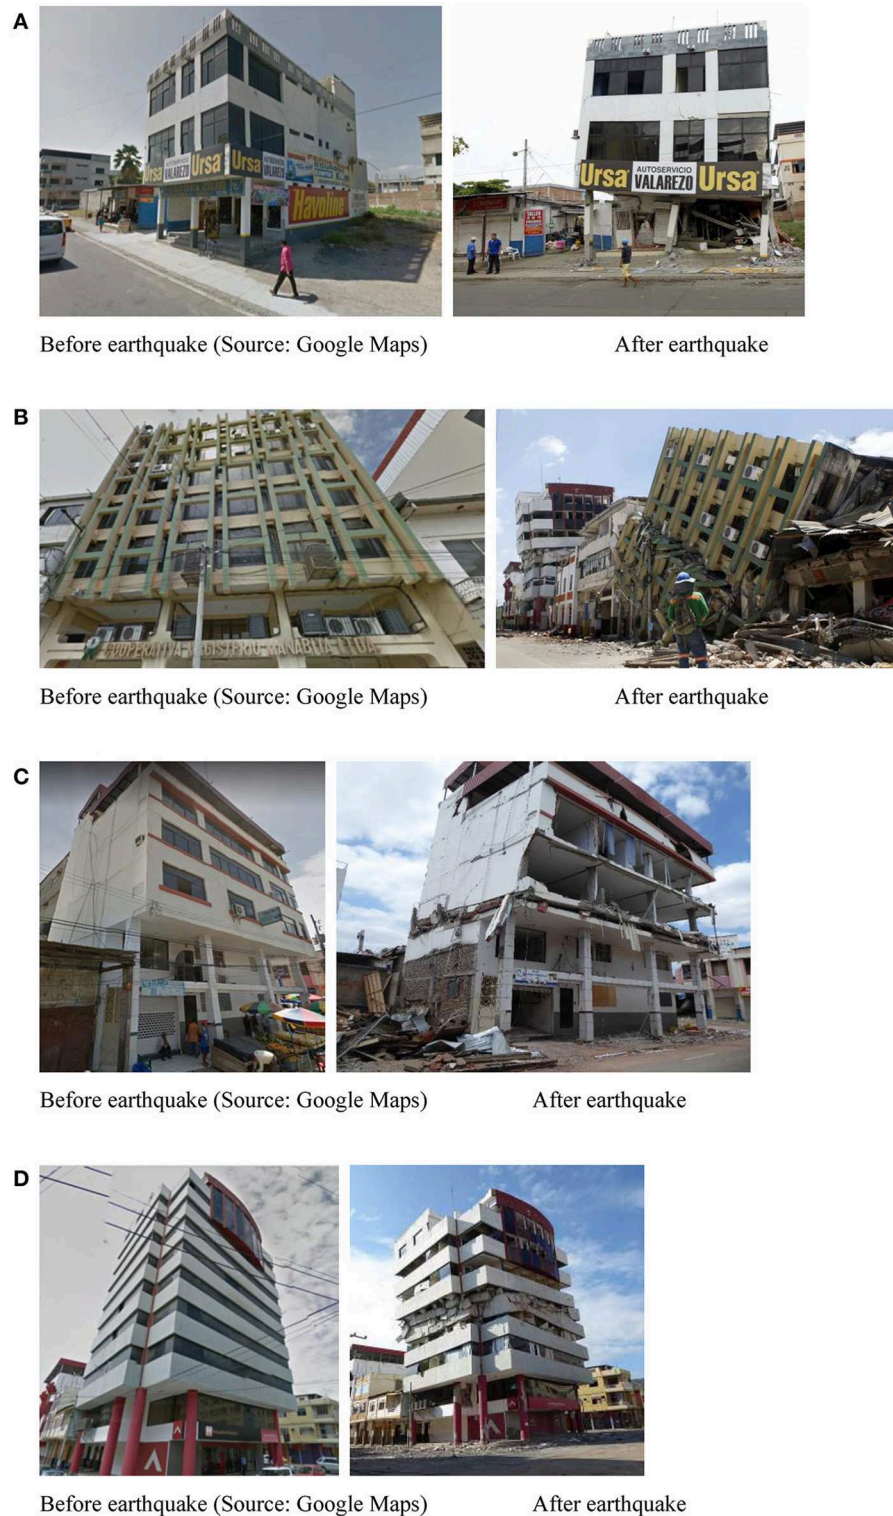
Most seismic induced soft-story collapse failures occur particularly at the ground level where there exist columns with minimal infill walls or simply due to higher loadings transferred from upper stories. Such typical soft-story failures, alike to those observed at Padang and Tōhoku, were observed as shown in **Figure 8A**. However, in contrast, there were also observations of upper floor soft-story failures in a number of buildings following this Muisne earthquake. Change in stiffness of the story or plan was one of the key factors leading to such occurrence of upper-story collapses. Examples include the Magistrate building and a commercial building in Portoviejo and Manta, respectively, where discontinuity of stiffness was observed, as shown in **Figures 8B,C**. There were however occasions where upper soft-story collapse occurred on buildings without obvious change in structural stiffness, plan or story height (e.g., **Figure 8D**). Further investigation appeared to confirm that such failure could be due to extension of the building long after the bottom floors

FIGURE 8 | Soft story collapse following the Muisne earthquakes. **(A)** soft story collapse at ground level of car garage at Manta. **(B)** Upper story collapse at the Magistrate building at Potoviejo due to change in stiffness at 1st floor. **(C)** Upper story collapse at commercial building at Manta due to change in stiffness at 2nd floor. **(D)** Upper story collapse at Mutualista Pichincha building in Portoviejo.
